GC Troubleshooting

1. Observation: no peaks

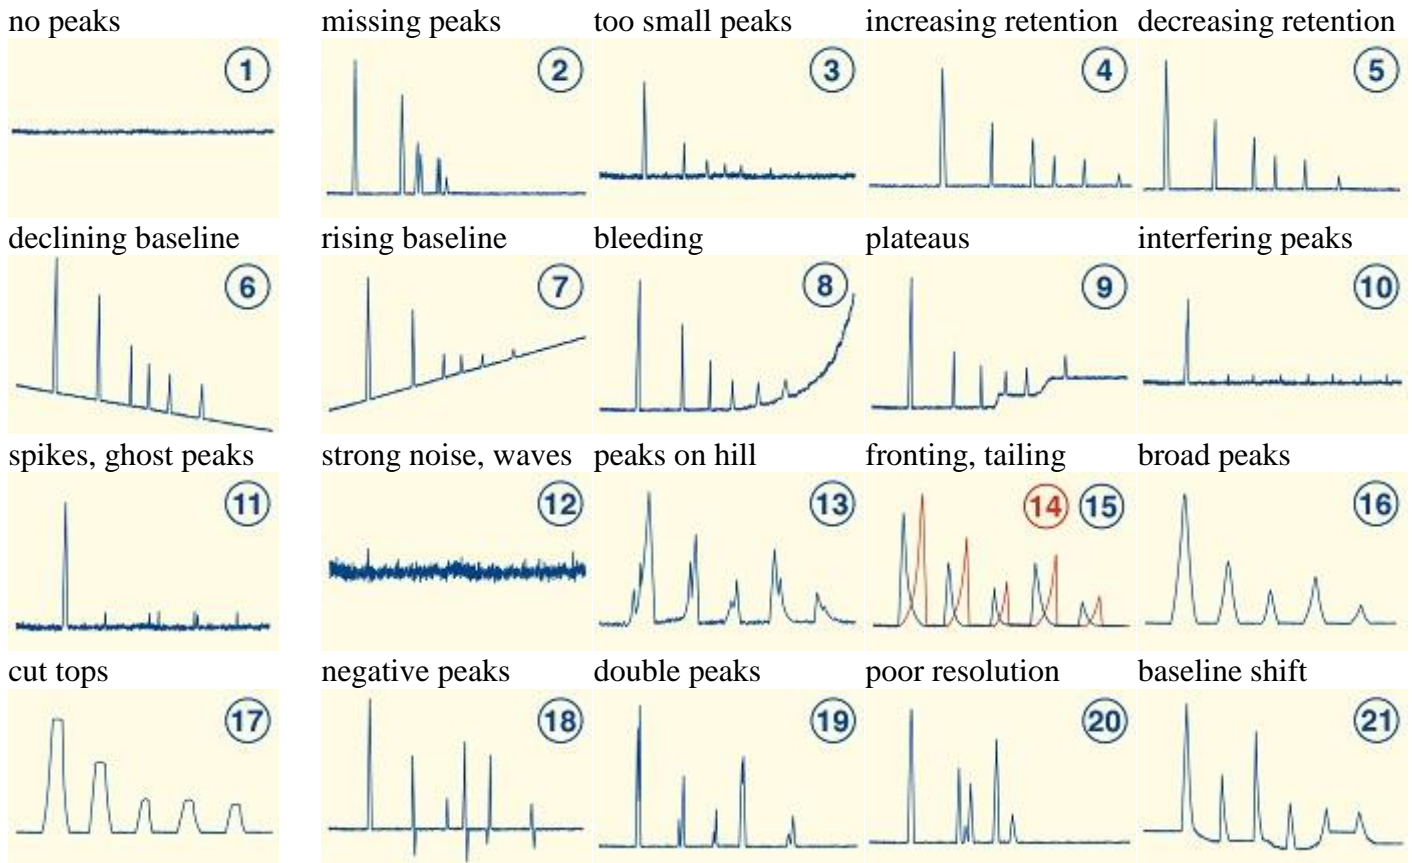
1. Observation no peak

①	Possible causes	Suggested remedy
	1. error in the detector power supply / electronics.	1. check detector/electronic power supply and cables.
	2. no FID flame.	2. check FID; reignite it.
	3. syringe defective / clogged.	3. use a different syringe or clean it.
	4. temperature too low for the analytes, oven heating faulty.	4. check temperature program, oven temperature.
	5. detector / software / computer hardware failure.	5. check integrator, cables; restart computer.
	6. no gas flow.	6. check gas tubes, valves, seals; test gas flow; shorten front of GC column, change injection septum.
	7. column connection leaks.	7. use new ferrules.
	8. broken GC column.	8. if breakage is at the beginning or at the end, remove the short piece; breakage in the middle can be mended with a glass
